BULGA COAL COMPLEX

Annual Environmental
Management Report 2009

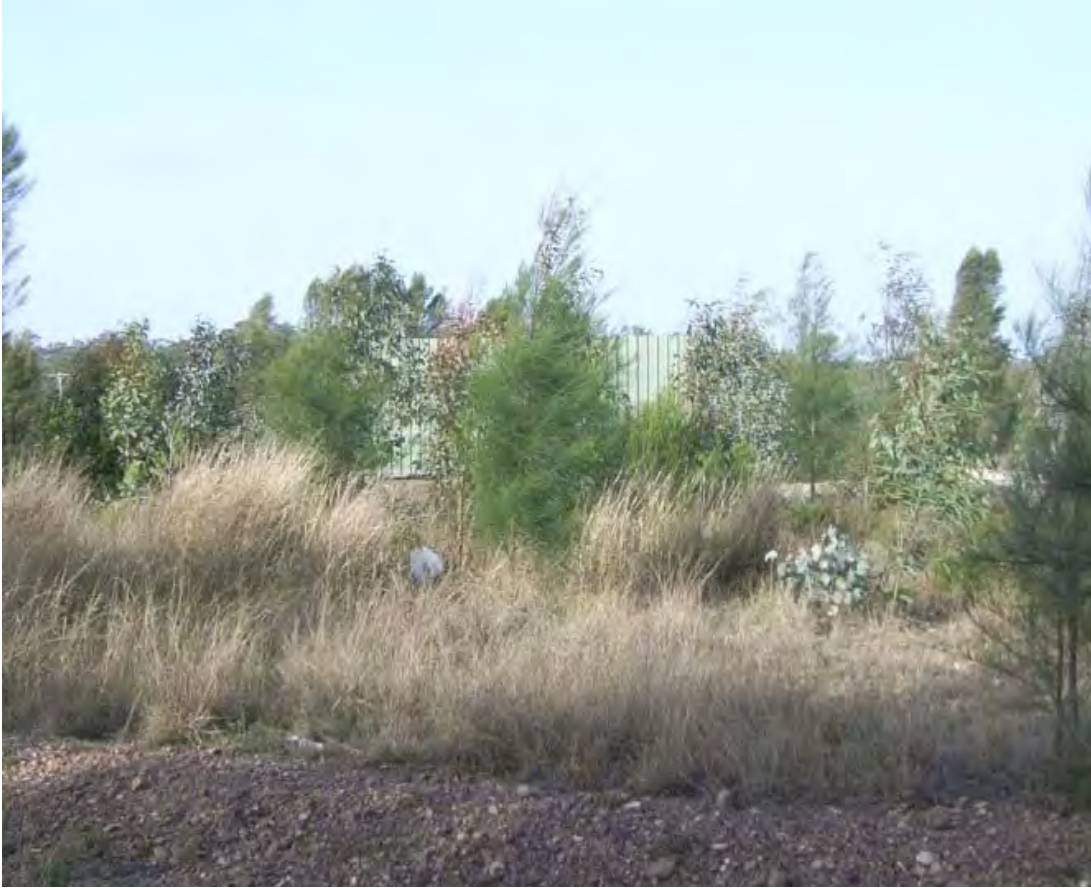
Plate 4-2 Native vegetation and Colourbond cladding visual screening

These barriers are supplemented with endemic tree and shrub species to further decrease the visual impact of infrastructure. An example of this type of visual screen is provided in **Plate 4-2**.

In addition to the visual screening of the gas drainage and mine dewatering infrastructure, the Underground Operations have endeavoured to keep the Bulga Coal Complex buffer land tidy, in particular the road verges and the area at the intersection of Broke and Charlton Roads. Details of the visual screening works and maintenance undertaken in these areas during the reporting period are provided in **Section 2.8.4**.
